## Case study: Submarine Crashes into Uncharted Seamount

On January 8, 2005, the nuclear submarine *USS San Francisco* ran aground enroute from Guam to Brisbane, Australia. In one of the worst submarine accidents in U.S. naval history, the sub crashed into a large seamount (an underwater volcano) that rose 2000 m from the surrounding ocean floor. The seamount could have been avoided if it had appeared on the navigational charts used by the sub. Four minutes before the crash the submarine's sonar measured a false depth of 2000 m. The crash actually occurred at a depth of ~160 m, while traveling at a speed of 33 knots or ~38 mph (by comparison the average cruising speed of most oceanographic research vessels is 10-12 knots). The impact of the collision punched huge holes in the forward ballast tanks of the sub (**Figure 1**), which in turn shut down the throttles, and caused the sub to drift listlessly, its bow pointing down. Luckily, the sub's nuclear reactor and the crew's quarters were not compromised. However, one crewman was killed in the accident and 115 were injured. The rest of the crew managed to keep the sub from sinking during a harrowing 30-hour, 360-mile transit back to

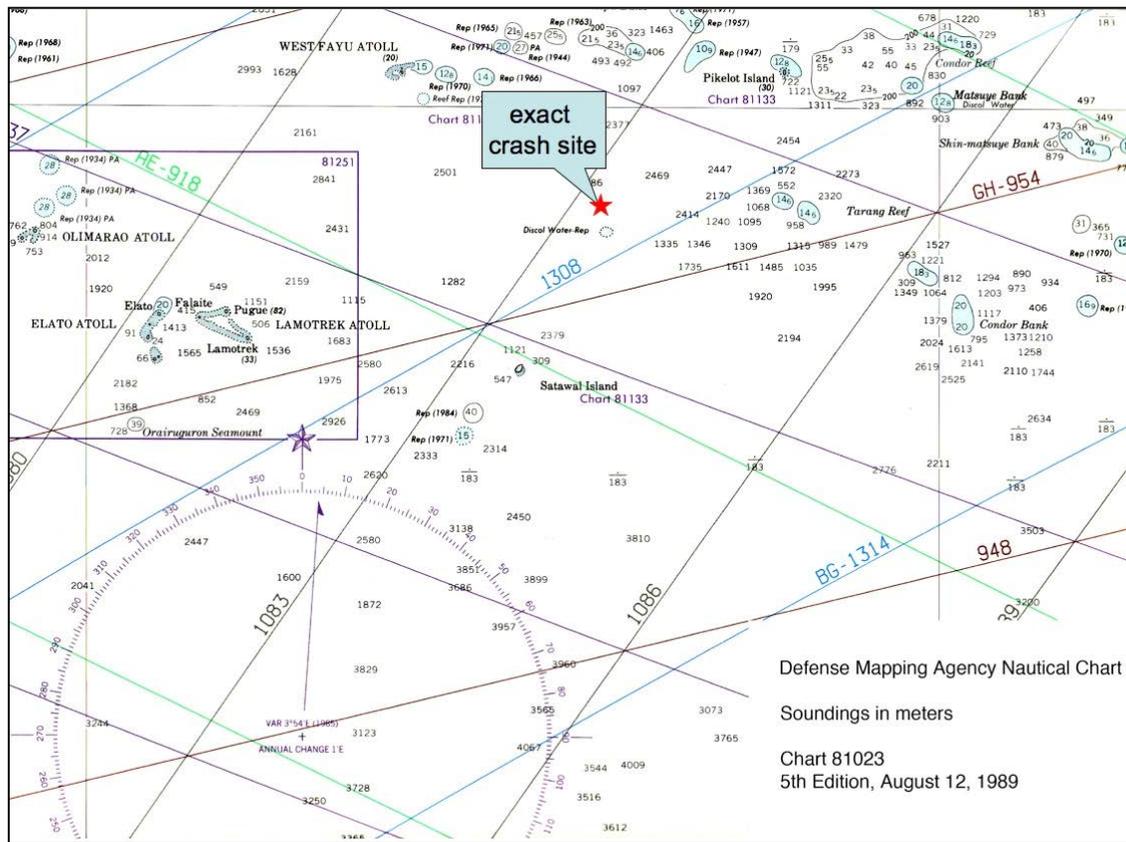
**Fig. 2.** Defense Mapping Agency (DMA) nautical chart of 1989 with the location marked of the submarine's collision with the seamount (Sandwell and Wessel, 2006). Note the paucity of soundings in the DMA's database for this part of the western Pacific.

commander, with fifteen other officers and enlisted men, as well as a review of Navy reports, raised questions about the training and support of U.S. submariners in general, but also the relatively primitive state of nautical charts upon which the crews rely. Navy officials reported that the main navigational chart in use by the crew was prepared in 1989 by the Defense Mapping Agency (DMA) and had never been revised. The chart did not show any potential obstacles within three nautical miles of the crash (Figure 2). Soon after the incident, Department of Defense (DoD) officials reported finding a Landsat satellite image from 1999 showing a seamount rising to within 100 feet of the sea surface in the area of the crash (as indicated by subtle variations in water color). Why hadn't the DMA updated their 1989 charts to show this feature? Navy officials said that the incident occurred in an area that was no longer of high priority for updating bathymetry (ocean floor topography) due to the cessation of the Cold War. Although the Navy began basing submarines out of Guam in 2002, it has focused improvement of its nautical charts in the shallow coastal waters of the Middle East as part of the "war on terror." The DMA had also consistently lacked the resources to properly compile, convert and interpret satellite data for the systematic updating of charts, nor had it been able to fully ensure the accuracy, precision, resolution, and validity of current charts. This agency has since been absorbed into the DoD's National Geospatial-Intelligence Agency (NGA), for the provision of maps, nautical charts and other geographic intelligence to the nation's combat forces.
